Project No. 5404G  
Date: August 10, 2005  
Tested at Humboldt

## **Final Report**

# **Reducing Canola Seed Damage from Metering and Air Distribution Systems**

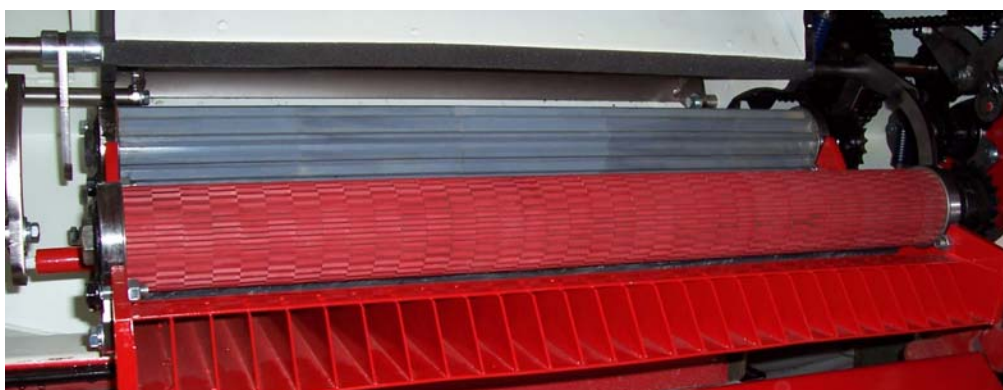
**Figure 3.** Fine and Medium Rollers.

A hydraulic motor with a flow control valve was mounted on the end of the metering drive wheel shaft and was used to simulate target ground speeds. A fine roller was used to meter the canola and a medium roller was used to meter the phosphate (**Figure 3**). Half of the small front tank was used for the seed due to the small seeding volumes associated with canola (**Figure 4**).

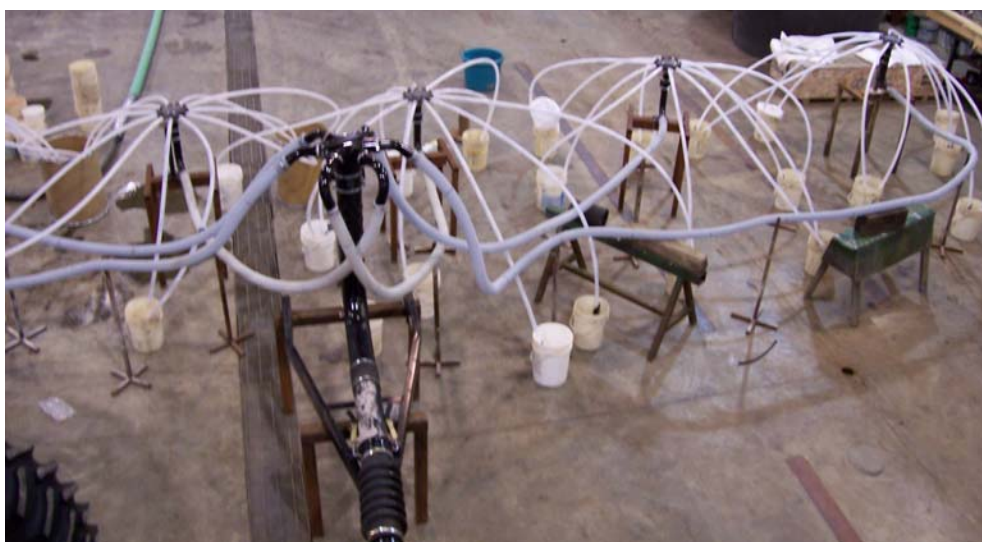
**Figure 5.** Air Kit Mounted on Test Stands.

**Bourgault:** The Bourgault system included a tow behind Bourgault 6550 air cart with an air kit mounted on test stands (**Figure 5**). Seed and fertilizer were metered from the air tank with an auger type system into one large primary distribution hose. The canola meter used a double fluted steel auger (**Figure 6**) while the fertilizer meter had a single

flight polyurethane auger. The primary hose ran past the rear of the air cart where it entered the bottom of the primary manifold with six outlets. Each of these hoses ran into a secondary manifold with 11 delivery hoses (**Figure 5**). The delivery hoses were inserted into plastic pails with cloth on the bottom to absorb the impact at the bottom of the pail. The standard Bourgault boots were very streamlined and probably would have caused little or no seed damage. They were left off of the hoses to help speed up the testing process. However, to verify this, additional tests were run after completion of the tests using the standard square Bourgault boot and Bourgault Tillage Tools 200-KNf-7510 narrow opener. When seeding with a Bourgault seeder, phosphate is always run with the seed. All of Bourgault's runs had phosphate included except for one run which was base minus P.

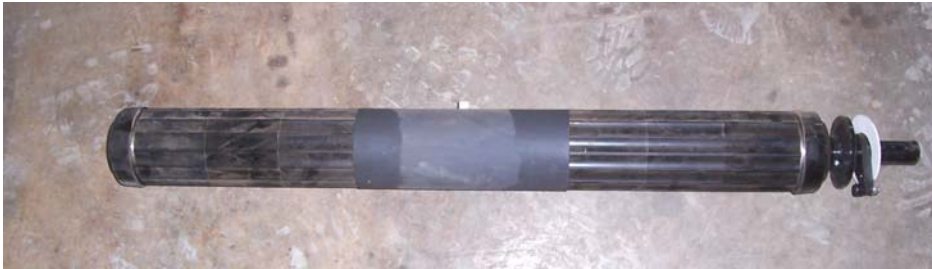
**Figure 7.** Long External Flutes Extra Fine Metering Roller.

**New Holland:** The New Holland system included a New Holland SC230 air cart with a 40 ft SD440 Air Drill. Seed is metered from one long external fluted extra fine metering roller into six individual distribution hoses (**Figure 7**), while a long external fluted coarse metering roller metered the phosphate into six individual distribution hoses. Each hose ran to a manifold with nine delivery hoses (**Figure 8**). The delivery hoses were inserted into the Flexi-Coil Stealth double-shoot side band openers and then placed into a pail with cloth on the bottom to absorb impact (**Figure 9**). The metering system on the New Holland air cart was operated with the factory New Holland electronically controlled drive system.
